NASA TN D-7703

FLIGHT EVALUATION OF ADVANCED
CONTROL SYSTEMS AND DISPLAYS
ON A GENERAL AVIATION AIRPLANE

*by Paul C. Loschke, Marvin R. Barber,
Einar K. Enevoldson, and Thomas C. McMurtry*

*Flight Research Center
Edwards, Calif. 93523*

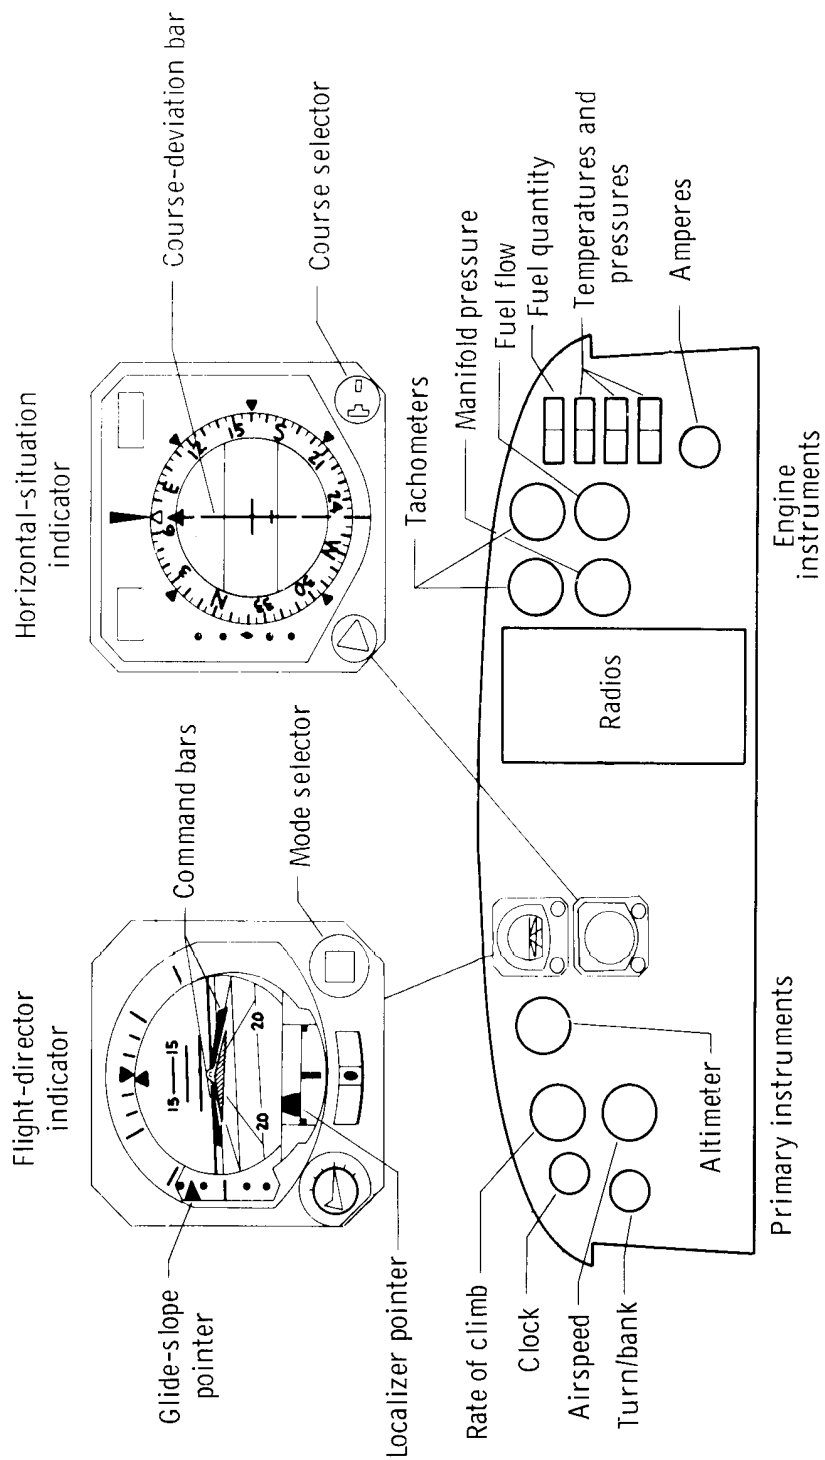
Figure 13. Flight-director display .

Flight-director display.— To investigate the effects of advanced integrated displays on handling qualities during instrument approaches in turbulence, a flight-director display was installed in the test airplane. The flight-director display (fig. 13) included two large and well organized instruments which presented the airplane's attitude, orientation, and position relative to the ILS beam (ref. 6). The display included a pitch and roll command symbol, which, when nulled, relieved the pilot of mental workload for such tasks as intercepting the ILS beam. Pitch and roll steering commands were computed from data received from the glide-slope and localizer receivers, a gyro-stabilized magnetic compass, and a vertical gyro. The heading, course, and steering modes were selected by the pilot and manually entered into the system.

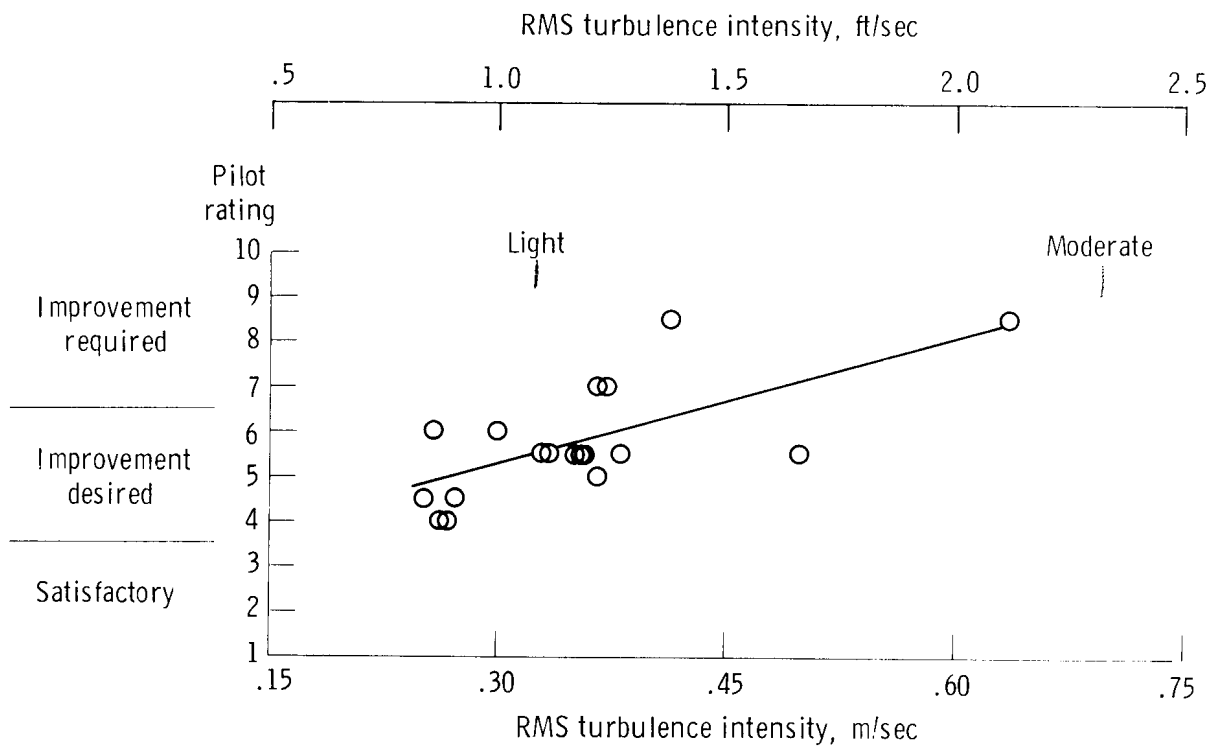
Figure 14. Pilot ratings of handling qualities for ILS approach task with basic control system.

Basic control system.— Figure 14 shows Cooper-Harper pilot ratings for the ILS approaches flown in the basic airplane. The figure shows the effect of atmospheric turbulence on the pilot's ability to perform the task. The ordinate is a condensation of the Cooper-Harper rating scale. The abscissa is the measured root-mean-squared (rms) value of turbulence intensity. The indications of light and moderate were determined from previous tests of the turbulence-intensity measurement system in the test airplane; the U.S. Weather Bureau's turbulence reporting criteria (table 2) were used as a basis for the determinations (ref. 8).

In relatively smooth air the airplane's handling qualities during the ILS approaches were rated 4, somewhat less than satisfactory. The rating degraded to 8 when the turbulence reached a moderate level. This rating indicated that the airplane's handling characteristics were unacceptable and that substantial pilot skill was necessary to maintain control. The airplane exhibited continual Dutch-roll oscillations and trim changes with power, both longitudinal and directional. Because of the poor instrument display and the light damping of the Dutch-roll

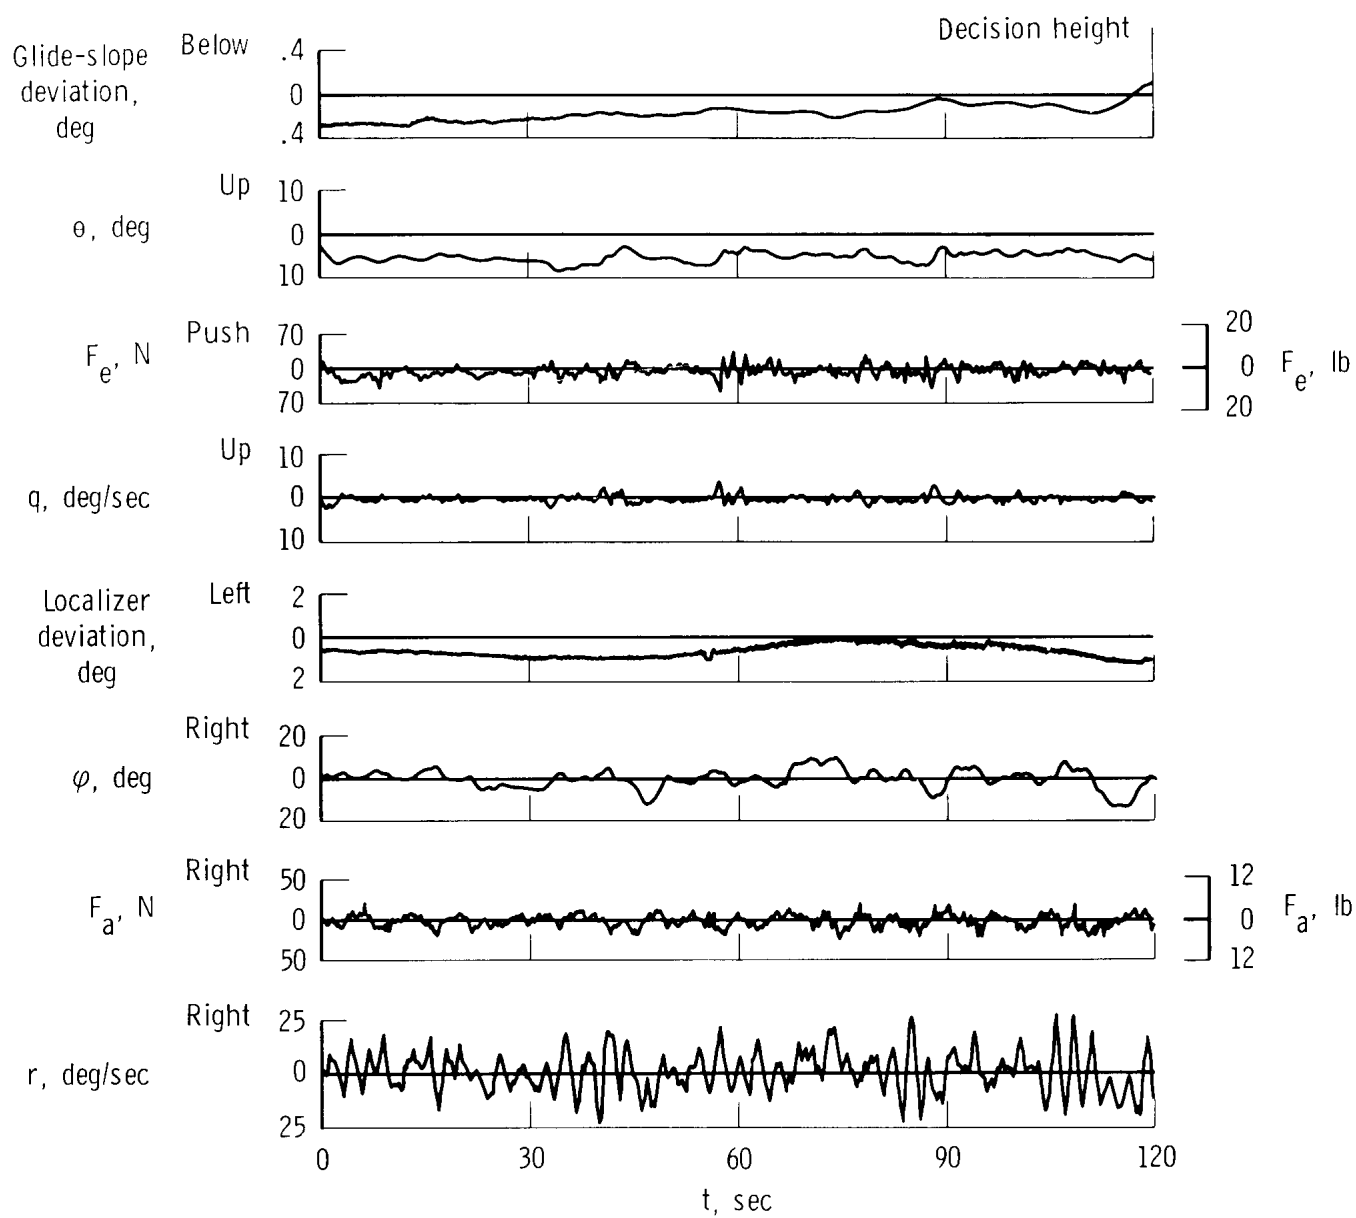
Figure 15. ILS approach in turbulence with basic control system and display.
 $V_i = 100$ knots; $\delta_f = 27^\circ$; gear down; measured turbulence = 0.44 m/sec
 $(1.45$ ft/sec) rms.

Figure 15 shows a time history of the last 2 minutes of a typical ILS approach in turbulence with the basic controls and the basic instrument display. A turbulence intensity of 0.44 meter per second (1.45 feet per second) rms was measured during the approach. The aircraft motion excited by gust disturbances is apparent in the rate and attitude traces. The large, lightly damped Dutch-roll oscillations shown in the yaw-rate trace continually rolled the airplane off the desired heading, which resulted in deviations from the localizer track. The high adverse yaw of the airplane compounded the azimuth control problem by introducing heading lag when small changes in heading were desired. Frequent and sometimes large lateral control inputs were necessary to keep the airplane within 1° of the localizer beam. Continuous disturbances in pitch attitude due to turbulence made it difficult to maintain trim and therefore caused large offsets and variations in the glide-slope error. Constant pilot inputs were necessary to keep the airplane within the $\pm 0.5^\circ$ limits of the glide-slope beam.

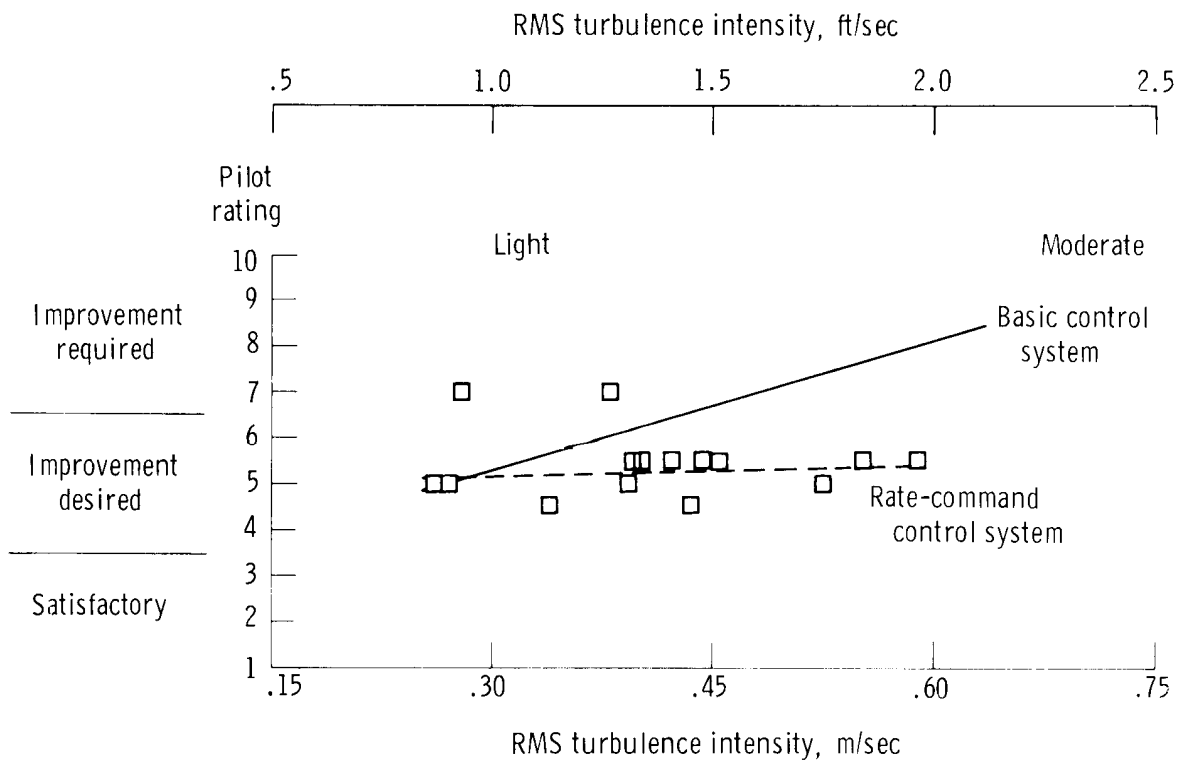
Figure 16. Pilot ratings of handling qualities of ILS approach task with basic and rate-command control systems.

Rate-command control system.— Figure 16 shows pilot ratings of the airplane's handling qualities with the rate-command control system and compares them with a fairing of the ratings obtained with the basic control system. With the rate-command control system, the handling qualities are still rated unsatisfactory. The ratings show that the airplane was no easier to control with the rate-command control system than with the basic control system in smooth air, but that the rate-command control system did improve the airplane's handling qualities at higher turbulence intensities. The pilots attributed the improvement partly to the damping of the airplane's response to gusts. The rate-command control system also improved the airplane's handling qualities by eliminating the trim changes with changes in power, gear, and flaps. However, the system was difficult to trim, and the airplane drifted continuously about the pitch and roll axes at a rate of approximately 5 degrees per minute. For this reason, constant attention was necessary to keep the airplane on the ILS beam.

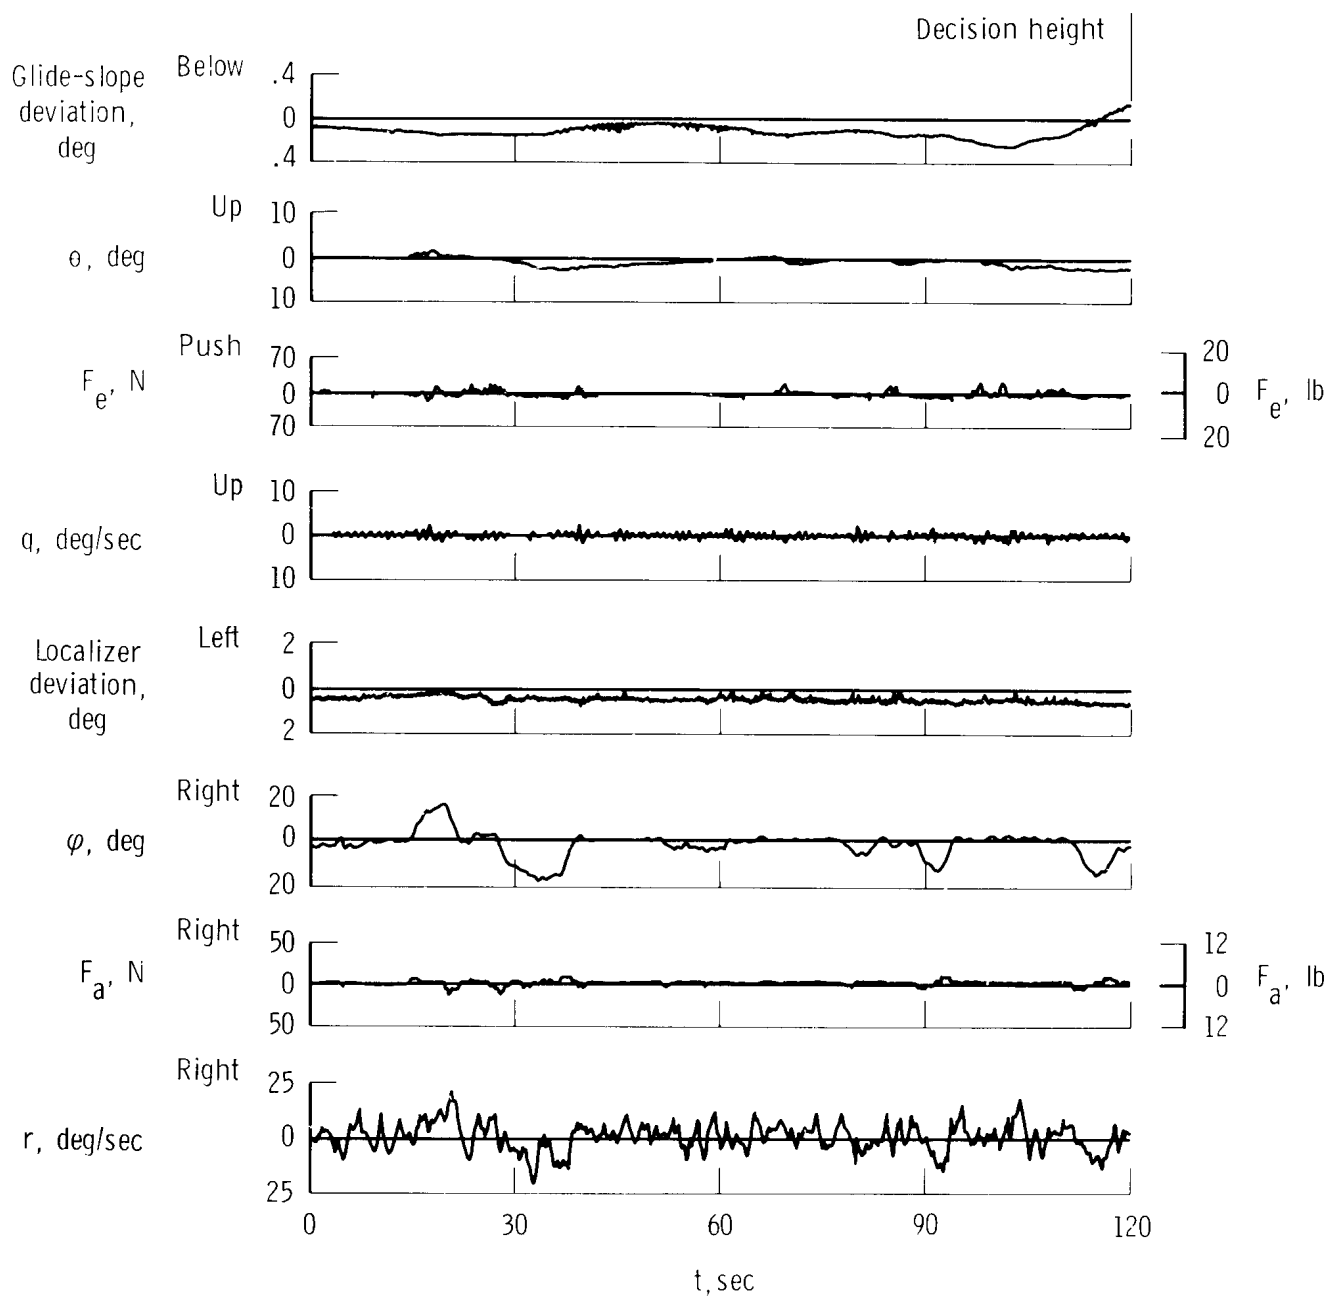
Figure 17. ILS approach in turbulence with rate-command control system and basic display. $V_i = 100$ knots; $\delta_f = 27^\circ$; gear down; measured turbulence = 0.43 m/sec (1.40 ft/sec) rms.

Figure 17 shows a time history of an ILS approach in turbulence with the rate-command control system and the basic instrument display. The measured turbulence recorded for the approach was 0.43 meter per second (1.40 feet per second) rms. A comparison with figure 15 shows the improvement in the airplane's handling qualities with the rate-command control system. Airplane motion was noticeably reduced. Yaw-rate response to turbulence was well damped except when large bank angles were commanded. Pitch and roll pilot inputs were considerably smaller than with the basic control system. The ILS glide-slope and localizer deviations were somewhat smaller than with the basic control system, although there was no significant improvement in tracking the beam.

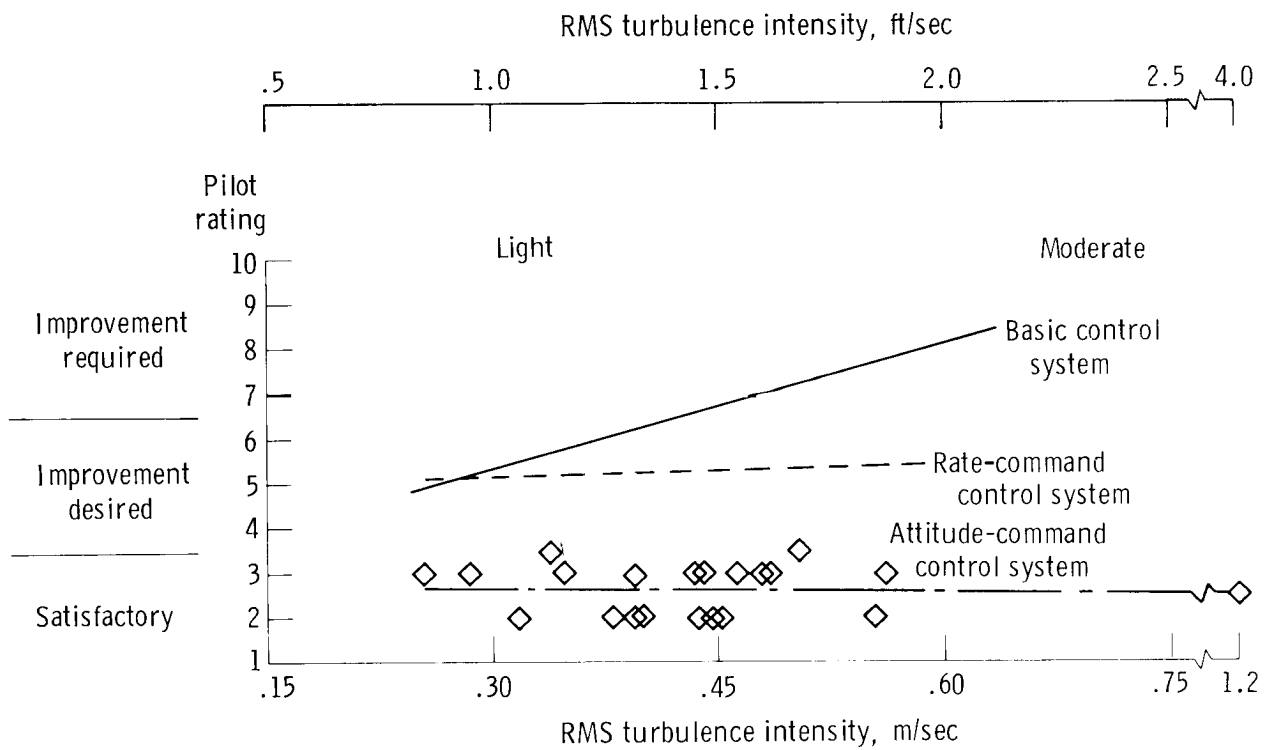
Figure 18. Pilot ratings of handling qualities for ILS approach task with basic, rate-command, and attitude-command control systems.

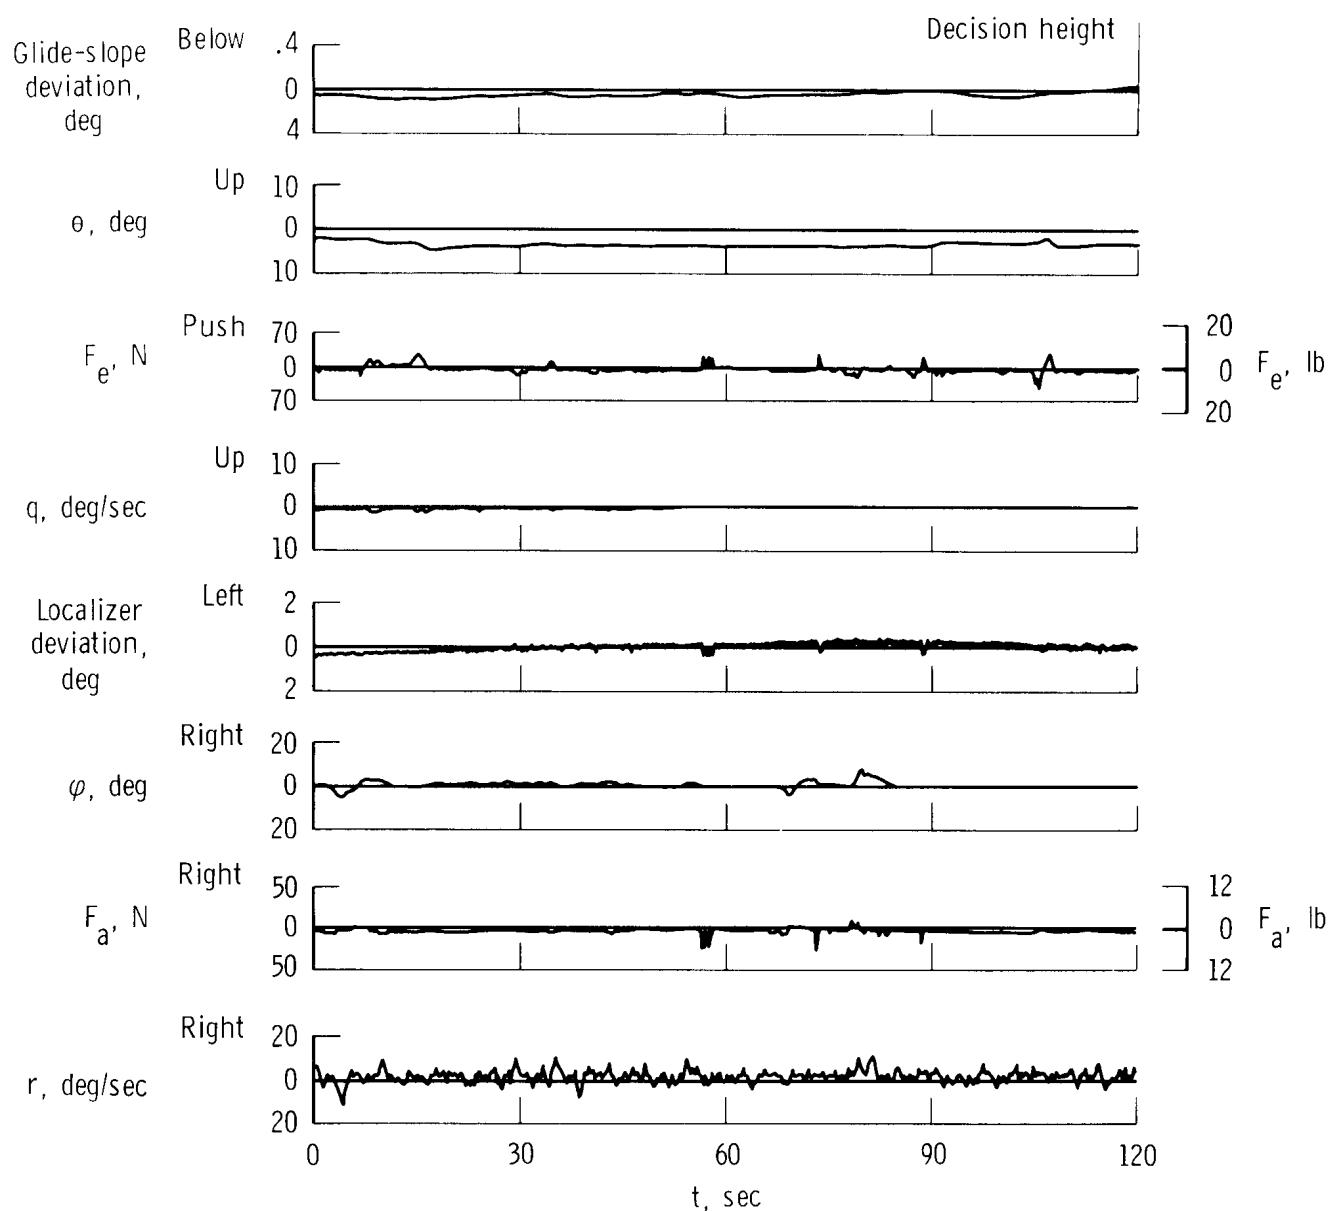
Figure 19. ILS approach in turbulence with attitude-command control system and basic display. $V_i = 100$ knots; $\delta_f = 27^\circ$; gear down; measured turbulence = 0.49 m/sec (1.60 ft/sec) rms.

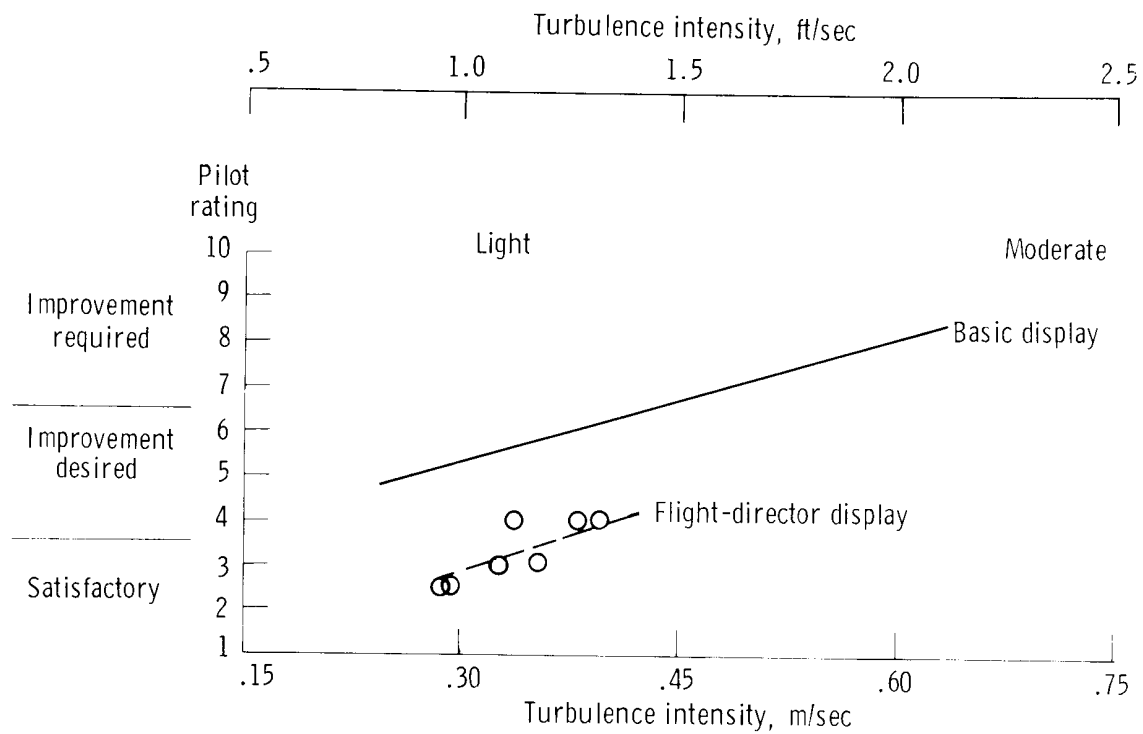
Figure 20. Pilot ratings of handling qualities for ILS approach task with basic control system with basic display and flight-director display.

Basic instrument and flight-director display.— Figure 20 presents the pilot ratings of handling qualities for ILS approaches flown with the basic instrument and flight-director displays in varying intensities of turbulence. With both display configurations, the basic control system was used during the approaches. The figure shows that the flight-director display significantly improved the pilots' opinions of the task. However, the handling qualities still degraded as turbulence intensity increased.

A comparison of figures 20 and 22 reveals that in smooth air the ratings of the basic display with the attitude-command control system and the flight-director display with the basic control system are approximately equal. However, turbulence degraded the ratings of the flight-director display with the basic control system at approximately the same rate as it did the ratings of the basic display with the basic control system.

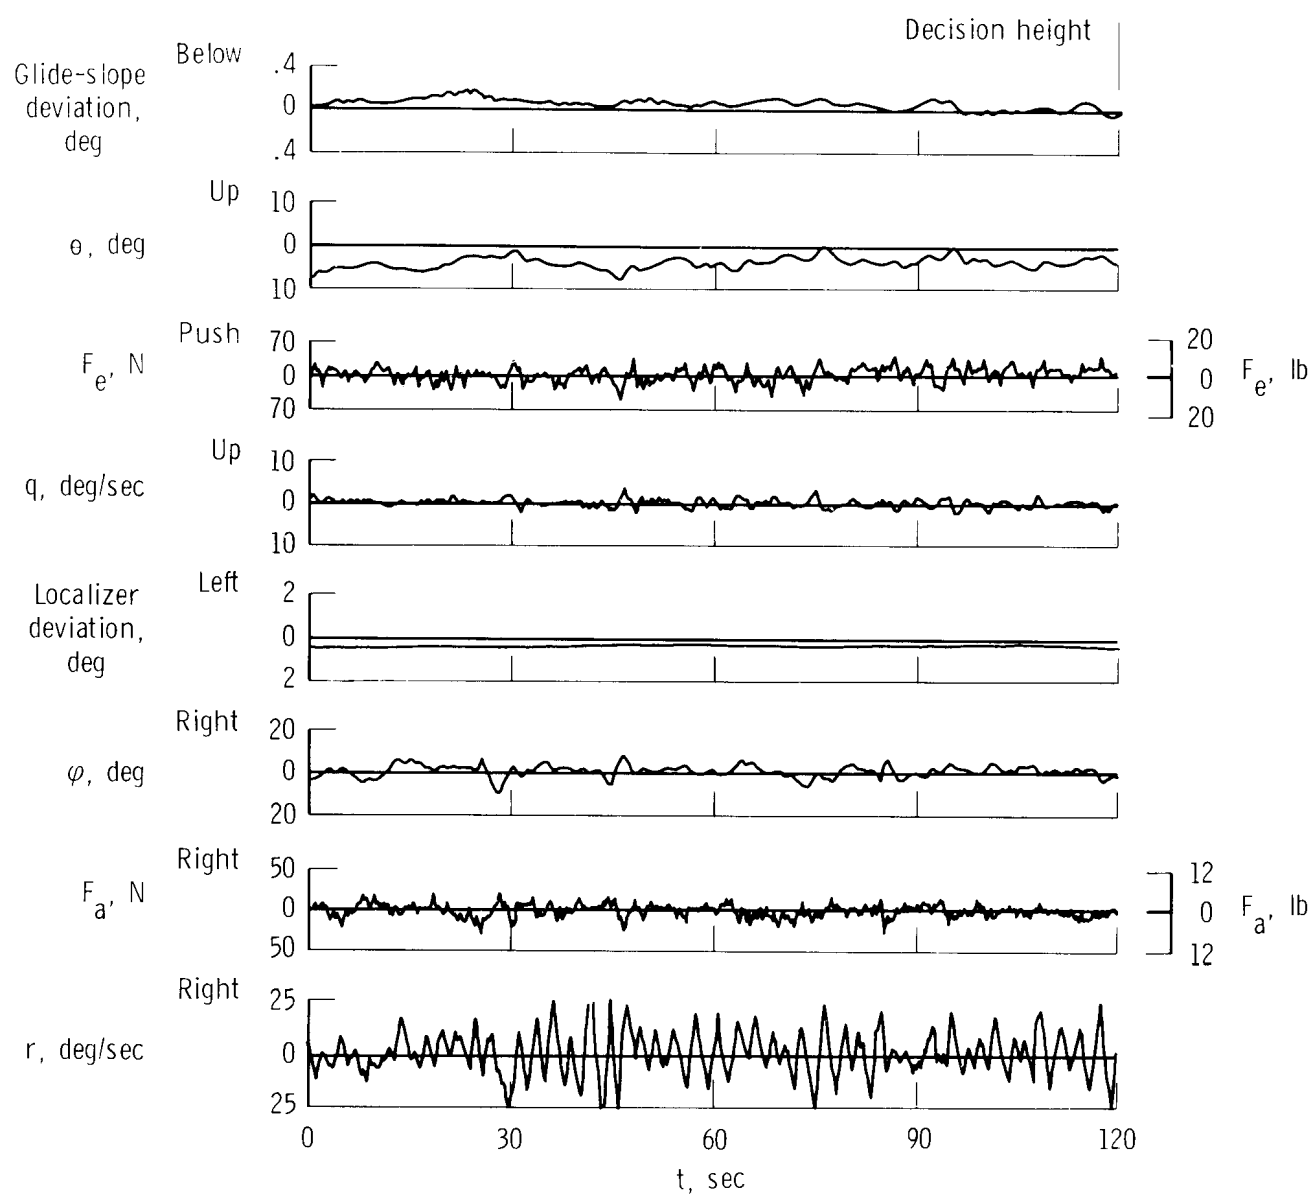
Figure 21. ILS approach in turbulence with basic control system and flight-director display. $V_i = 100$ knots; $\delta_f = 27^\circ$; gear down; measured turbulence = 0.40 m/sec (1.32 ft/sec) rms.

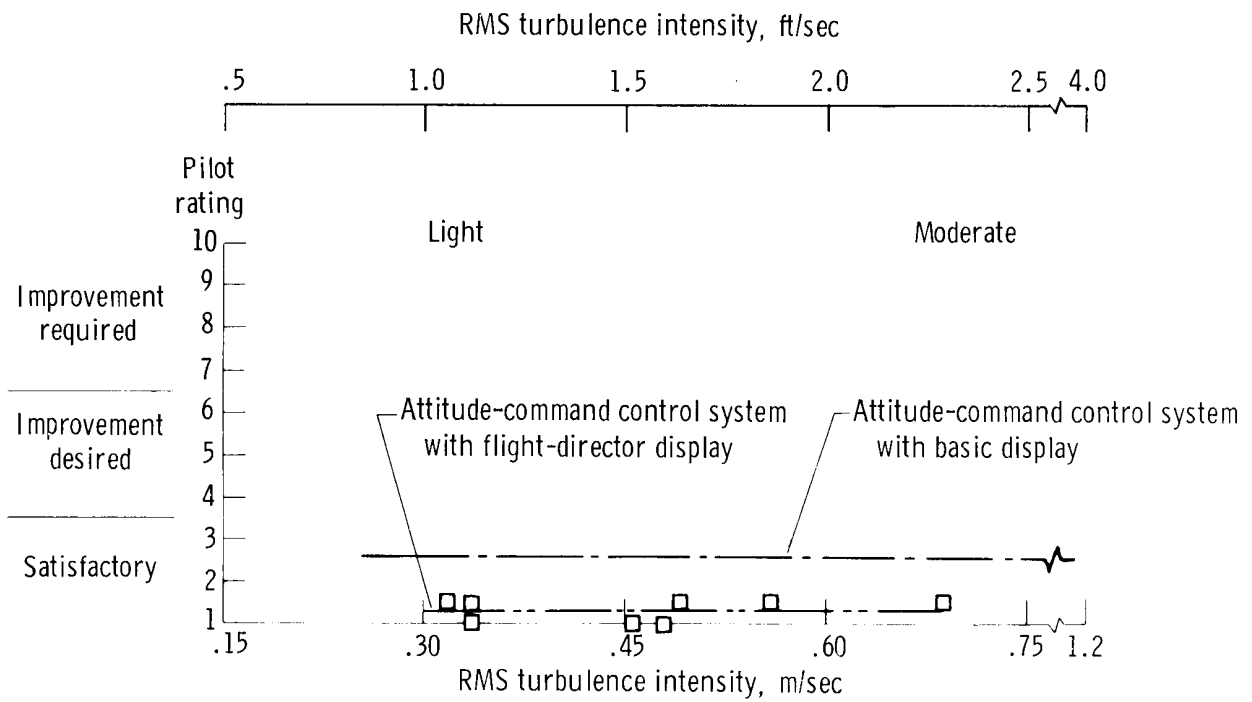
Figure 22. Pilot ratings of handling qualities for ILS approach task with attitude-command control system with basic display and flight-director display.

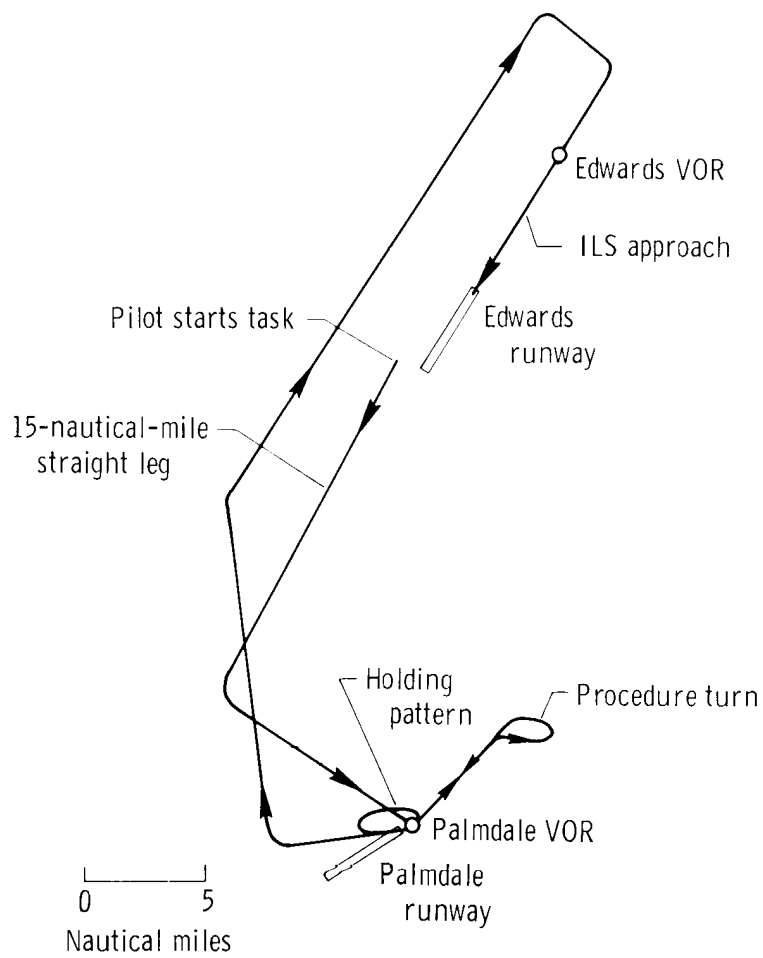
Figure 23. Pattern of IFR mission flown by noninstrument-rated pilots.

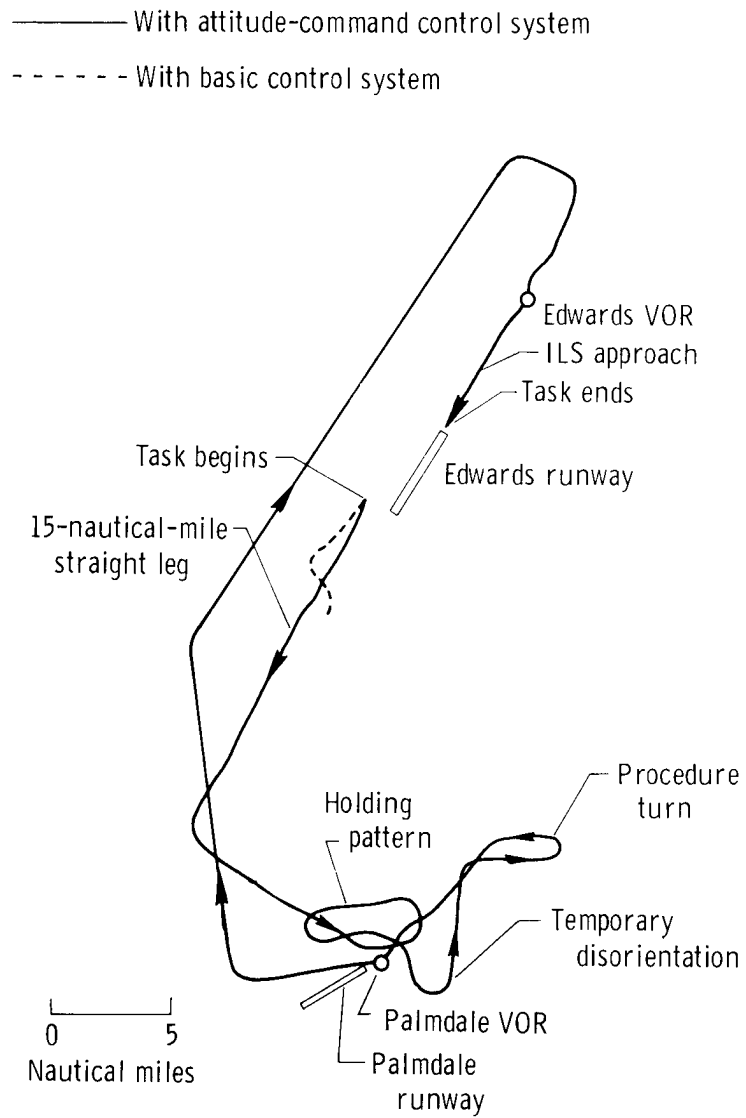
Figure 24. Performance of one VFR pilot flying the IFR mission with and without attitude-command control system.

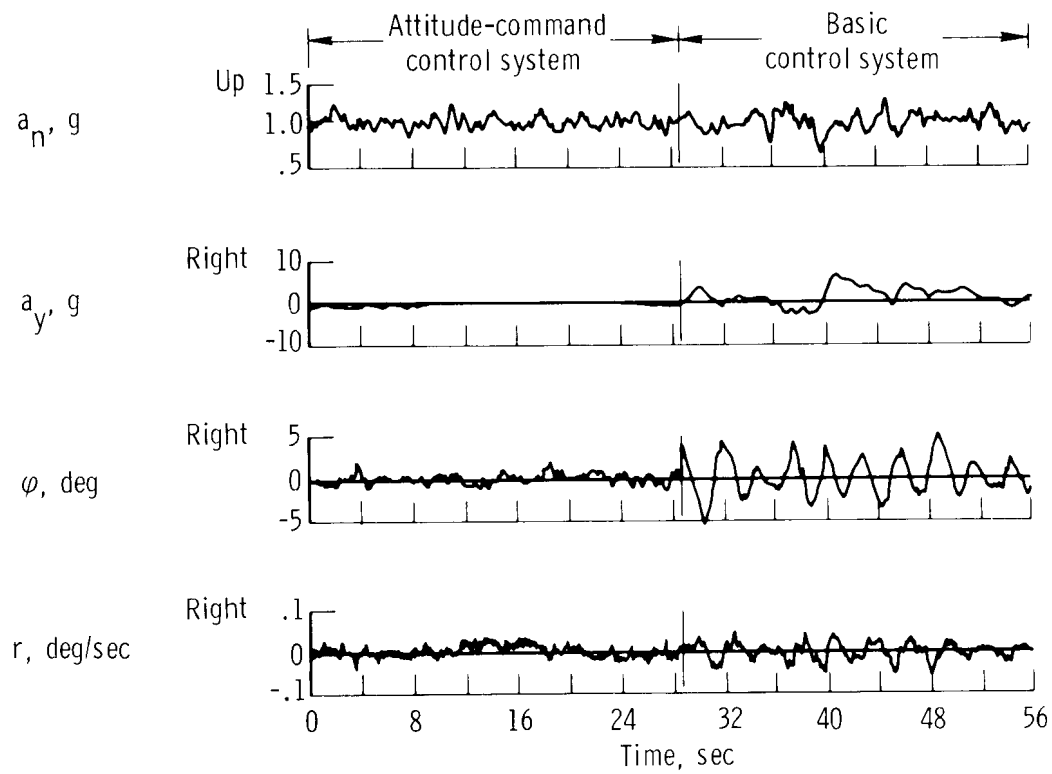
Figure 25. Comparison of airplane response to turbulence with attitude-command and basic control systems. Measured turbulence = 0.52 m/sec (1.7 ft/sec).

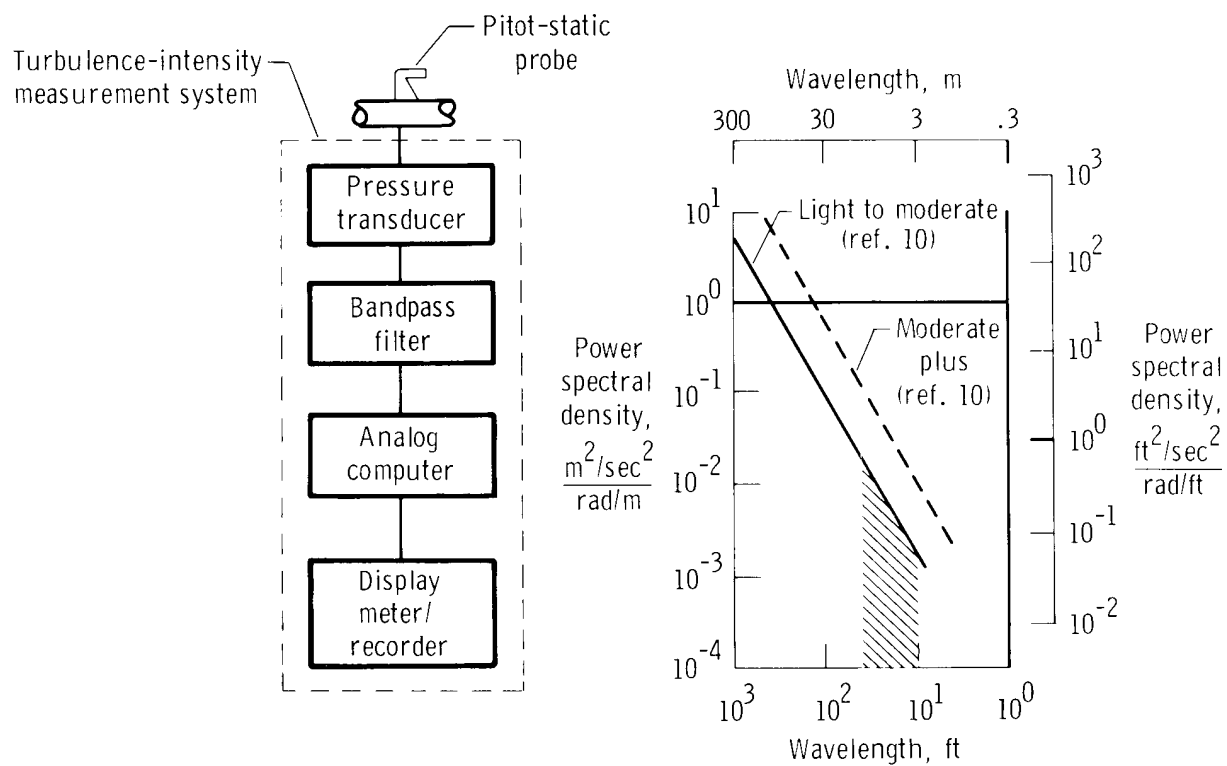
Figure 26. Turbulence-intensity measurement system.

It was obvious at the outset that the research flight control system would conceal turbulence from the pilot to some extent. Therefore, a turbulence-intensity measurement system was used during the program to measure the turbulence in which the airplane was operating (ref. 7). The turbulence-intensity measurement system is described in detail in the appendix.
